RESOLUTION NO. 2022-13

A RESOLUTION OF THE MAYOR AND COUNCIL OF THE CITY OF
GOTHENBURG, NEBRASKA, DECLARING A CERTAIN AREAS TO BE
BLIGHTED AND SUBSTANDARD AND IN NEED OF REDEVELOPMENT
PURSUANT TO THE COMMUNITY DEVELOPMENT LAW, CHAPTER 18,
ARTICLE 21, REISSUE REVISED STATUTES OF NEBRASKA, AS AMENDED

Gothenburg, Nebraska

Blight & Substandard Determination Study &
General Redevelopment Plan.

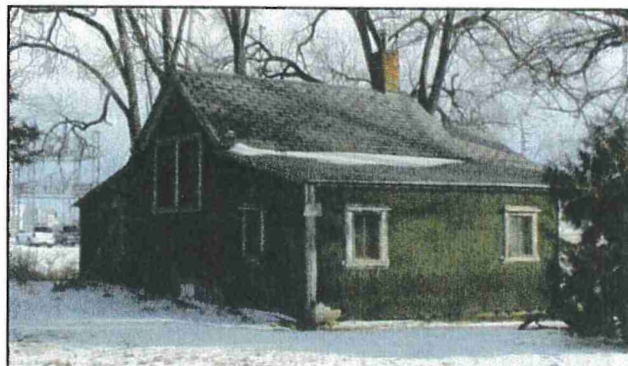
There are wood framed buildings with combustible elements and fixtures located throughout **Redevelopment Area #1**. A total of **81 structures**, or **29 percent** of the total **282 buildings** were rated as **deteriorating with major defects** and an additional **40 structures**, or **14 percent** as **dilapidated**.

A total of **192 structures**, or **68 percent** of the total **282 structures** in the **Redevelopment Area** were built prior to 1978, thus 40+ years of age. The average age of all structures is estimated to be 78 years, while the average age of residential structures alone is estimated to be 94 years.

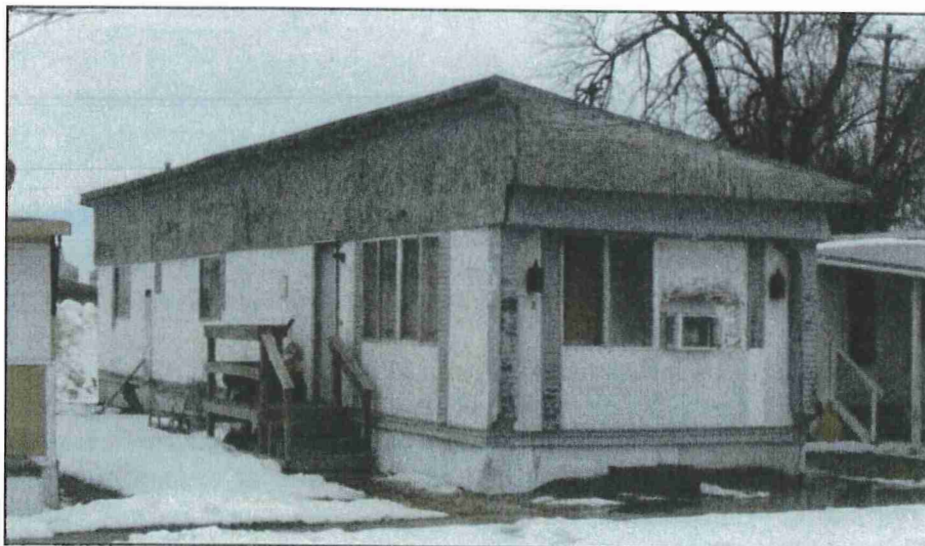
<u>Activity</u>	<u>Structural Condition Rating</u>				<u>Number of Structures</u>	<u>Deteriorating Major and/ or Dilapidated</u>
	<u>Sound</u>	<u>Deteriorating (Minor)</u>	<u>Deteriorating (Major)</u>	<u>Dilapidated</u>		
Residential	31	44	49	28	152	77
Commercial	29	20	20	5	74	25
Industrial	26	8	12	7	53	19
<u>Other</u>	<u>2</u>	<u>1</u>	<u>0</u>	<u>0</u>	<u>3</u>	<u>0</u>
Totals	88	73	81	40	282	121
Percent	31.2%	25.9%	28.7%	14.2%	100.0%	42.9%

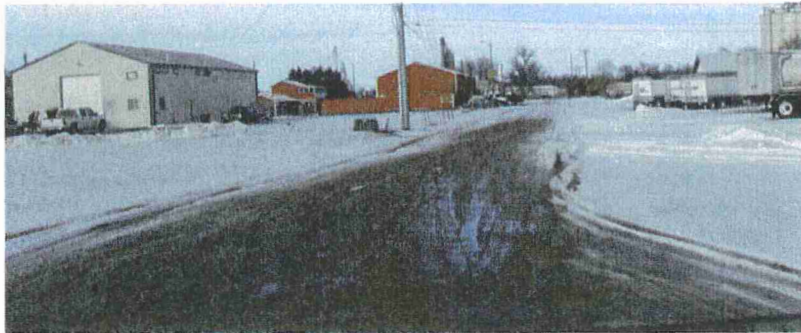
2. **Condition of streets.**

Street conditions throughout **Redevelopment Area #1**, overall, were found to be in "fair" condition. The majority of the streets within the **Area** are concrete with curbs and gutters. An estimated 121 parcels, or 32 percent, front on streets that are gravel surfaced with open storm gutters. Many of these gravel surfaced streets in the southern portion of the **Redevelopment Area** are accessed by existing undeveloped or industrial land use areas. Several privately owned driveways and parking areas are gravel surfaced.

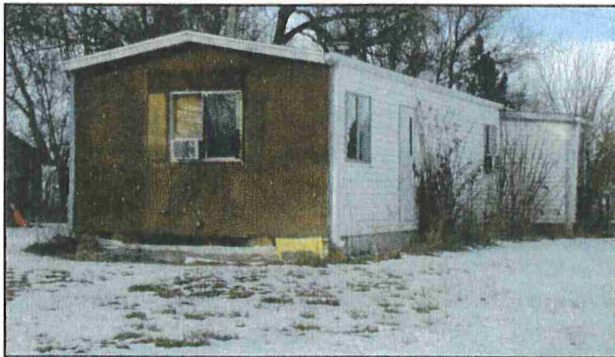
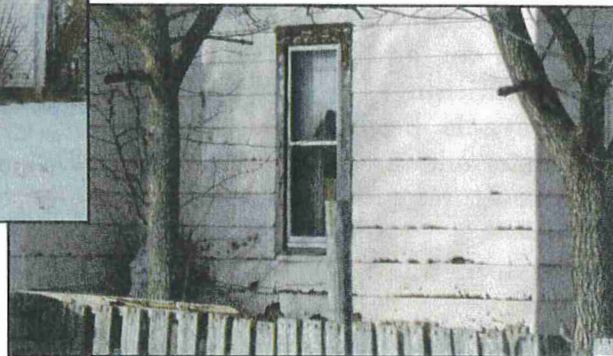
There are wood framed buildings with combustible elements and fixtures located throughout **Redevelopment Area #1**. A total of **81 structures**, or **29 percent** of the total 282 buildings were rated as **deteriorating with major defects** and an **additional 40 structures**, or **14 percent** as **dilapidated**.

A total of **192 structures**, or **68 percent** of the total **282 structures** in the **Redevelopment Area** were built prior to 1978, thus 40+ years of age. The average age of all structures is estimated to be 78 years, while the average age of residential structures, alone, is estimated to be 94 years.
